RAILWAY INVESTIGATION REPORT

R01D0097

DERAILMENT

CANADIAN NATIONAL TRAIN Q-137-11-28

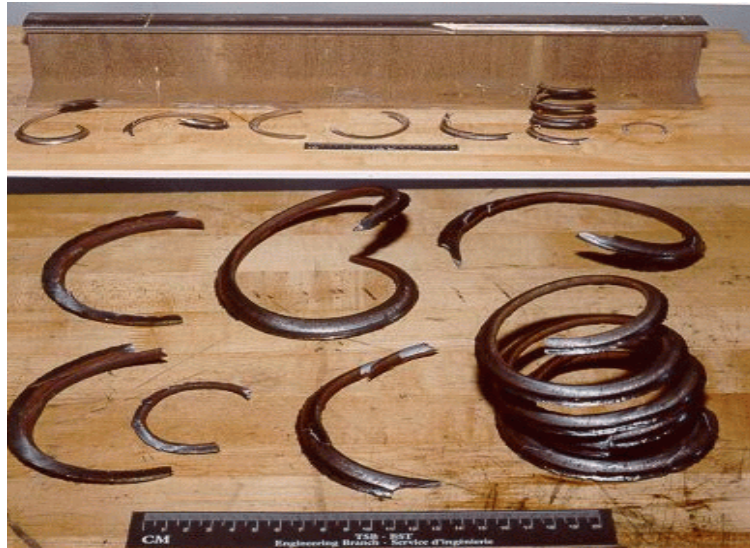
The derailment occurred in a curve that veers 8.29 degrees to the right (relative to the direction in which the train was moving). Examination of the track revealed that between Mile 1.50 and Mile 1.67, the flow lip on the gauge side of the north rail (the low rail in the curve) had been sheared off, forming spiral curls of rail material of various lengths (see Figure 1). At Mile 1.67, the end of the curve, there were witness marks 28 cm (11 inches) in length along the rail surface (see Figure 2) and narrow gashes in the wood ties. The pile-up of cars was located approximately 2000 feet west of the marks on the rail.

Figure 1. Curled strips of flow lip sheared from the rail

The curled strips of metal observed near the north rail indicate that the wheel flange had sheared off a band of metal consisting of the flow lip of the north rail. The marks observed on the north rail indicate that two pairs of wheels from one truck overran the running surface and fell outside the rail. The imprint left on the wooden ties came from wheels whose flanges had an unusual profile matching that of the wheels of truck D of platform C on car DTTX 25335, the first car to derail.

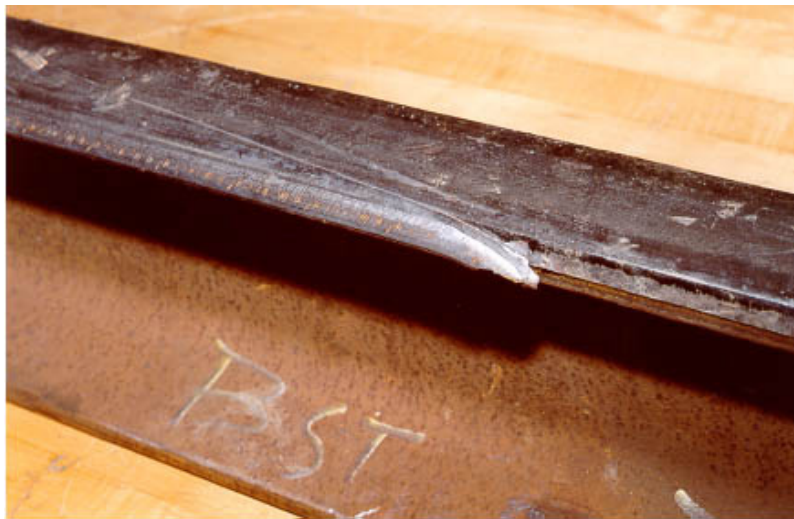
The TSB Engineering Laboratory examination (Report No. LP 71/01) showed that there was a flow lip up to 12 mm thick on the gauge side of the railhead. There was no flow lip on the field side of the rail.

Figure 2. Witness marks and sheared flow lip on the gauge side of the north railhead

In the present case, the flow lip was not removed by the traffic, and as a result, the rail had a flow lip measuring up to 12 mm. Consequently, it is likely that this flow lip was already present on the field side of the rail when it was transposed in 1999; however, no corrective grinding was done before or immediately after the transposition to eliminate the flow lip.

Moreover, the rail grinding train, which came through in June 2001, did not remove the flow lip, even though a correction of the rail profile was performed. In addition, the sum of the rail wear exceeded the maximum limit allowed by SPC 3200, but no corrective action was taken.

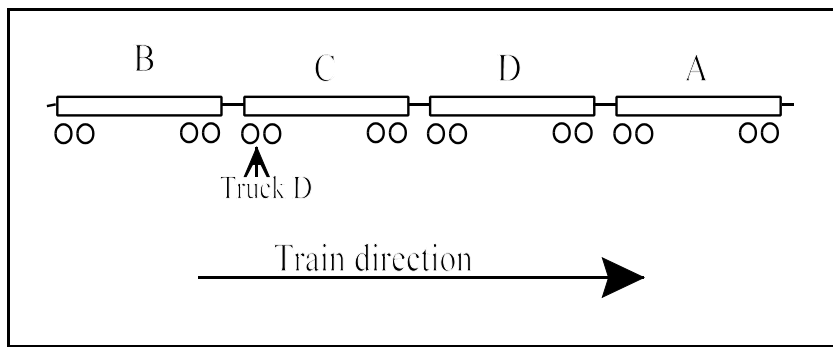
Platform C of car DTTX 25335, the first car to derail, was carrying a 40-foot container placed on top of two 20-foot containers. The three containers were loaded and weighed 64 tonnes. The wheels on the north side of truck D had a vertical flange wear of 24 mm (15/16 inch) and a flange height of 37 mm (1 7/16 inch). The Association of American Railroads (AAR) *Field Manual* provides maximum limits of 1 inch for vertical wear and 1 ½ inches for flange height.

Figure 3. Configuration of car DTTX 25335

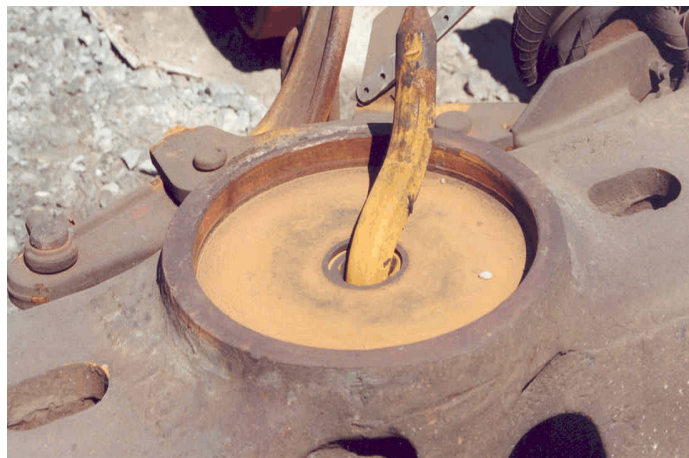
The body (male) centre plate and the truck (female) centre plate of truck D on the platform in question showed signs of abrasion and wear. The centre pin was bent but had remained in place (see Figure 4).

Figure 4. Centre plate and pin of truck D

The wear and abrasion noted on the body centre plate and the truck centre plate of truck D of platform C on car DTTX 25335 indicate that, most likely, the platform had been lifted, causing the body centre plate to uncouple from the truck centre plate. They were held together, however, by the centre pin, which remained in place. When the body centre plate is not

CN has issued a directive indicating that any car lifted by means of a crane during the unloading process must be inspected before it departs, failing which, it is to be taken out of service. This directive applies even if the car seems to have been properly reseated in the truck centre plate. The inspection must include a check to ensure that the centre pin is still in position. Any irregularity observed by inspectors must be recorded in a log.
